HU Modification (Adding L716 jumper)

HU WHICH DOES NOT RECOGNIZE Cd changer emulator/interface

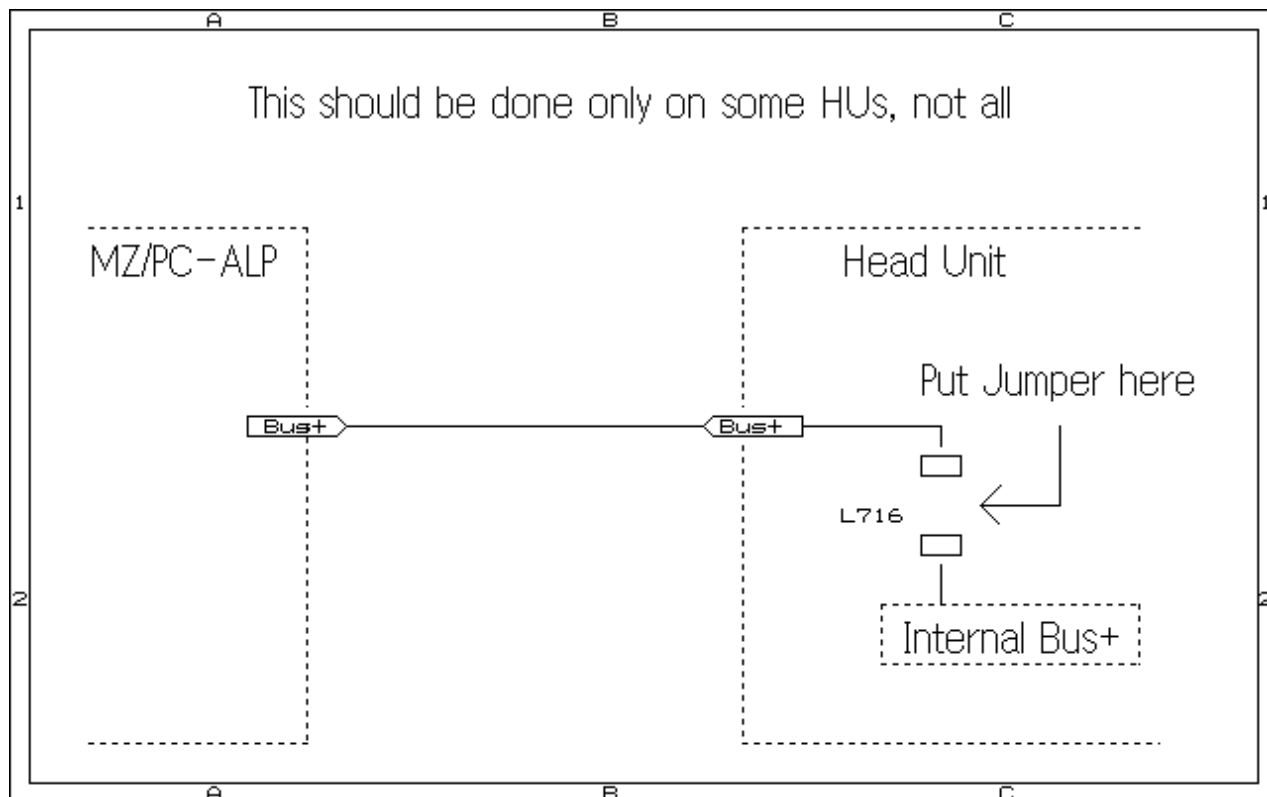
There are at least two versions of Panasonic (Matsusita) HU on the market. If your Mazda6 stereo is manufactured in 2003 - 2005 - chances are HU does not recognize car interface. This is because newer HUs do not have the zero ohm register on the PCB location L716 . To solve this problem, you must take the HU out, open HU (it voids warranty) and solder a Jumper or a 0-ohm chip register on location L716.

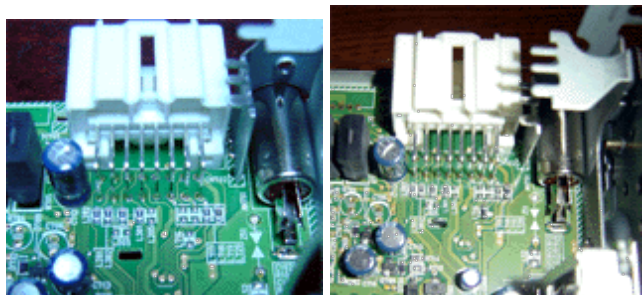
4.LOCATE L716

Click each pictures for exact location of L716.

Bridge L716 soldering pads with thin wire. Be careful not to short other circuits. Left picture above shows L716 open and right picture shows 0ohm chip register soldered.

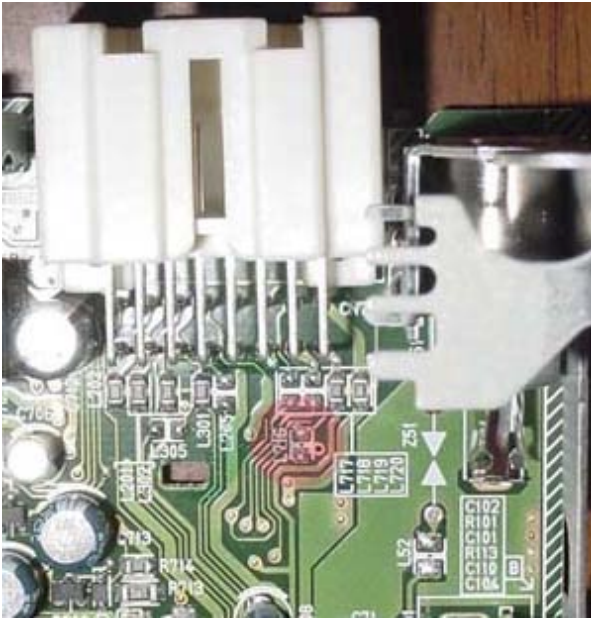
Another close up of L716 without jumper.
(Photo taken by [SIGURE](#))
